Snow Avalanches Along Colorado Mountain Highways

by Hans Frutiger

ROCKY MOUNTAIN FOREST AND RANGE EXPERIMENT STATION

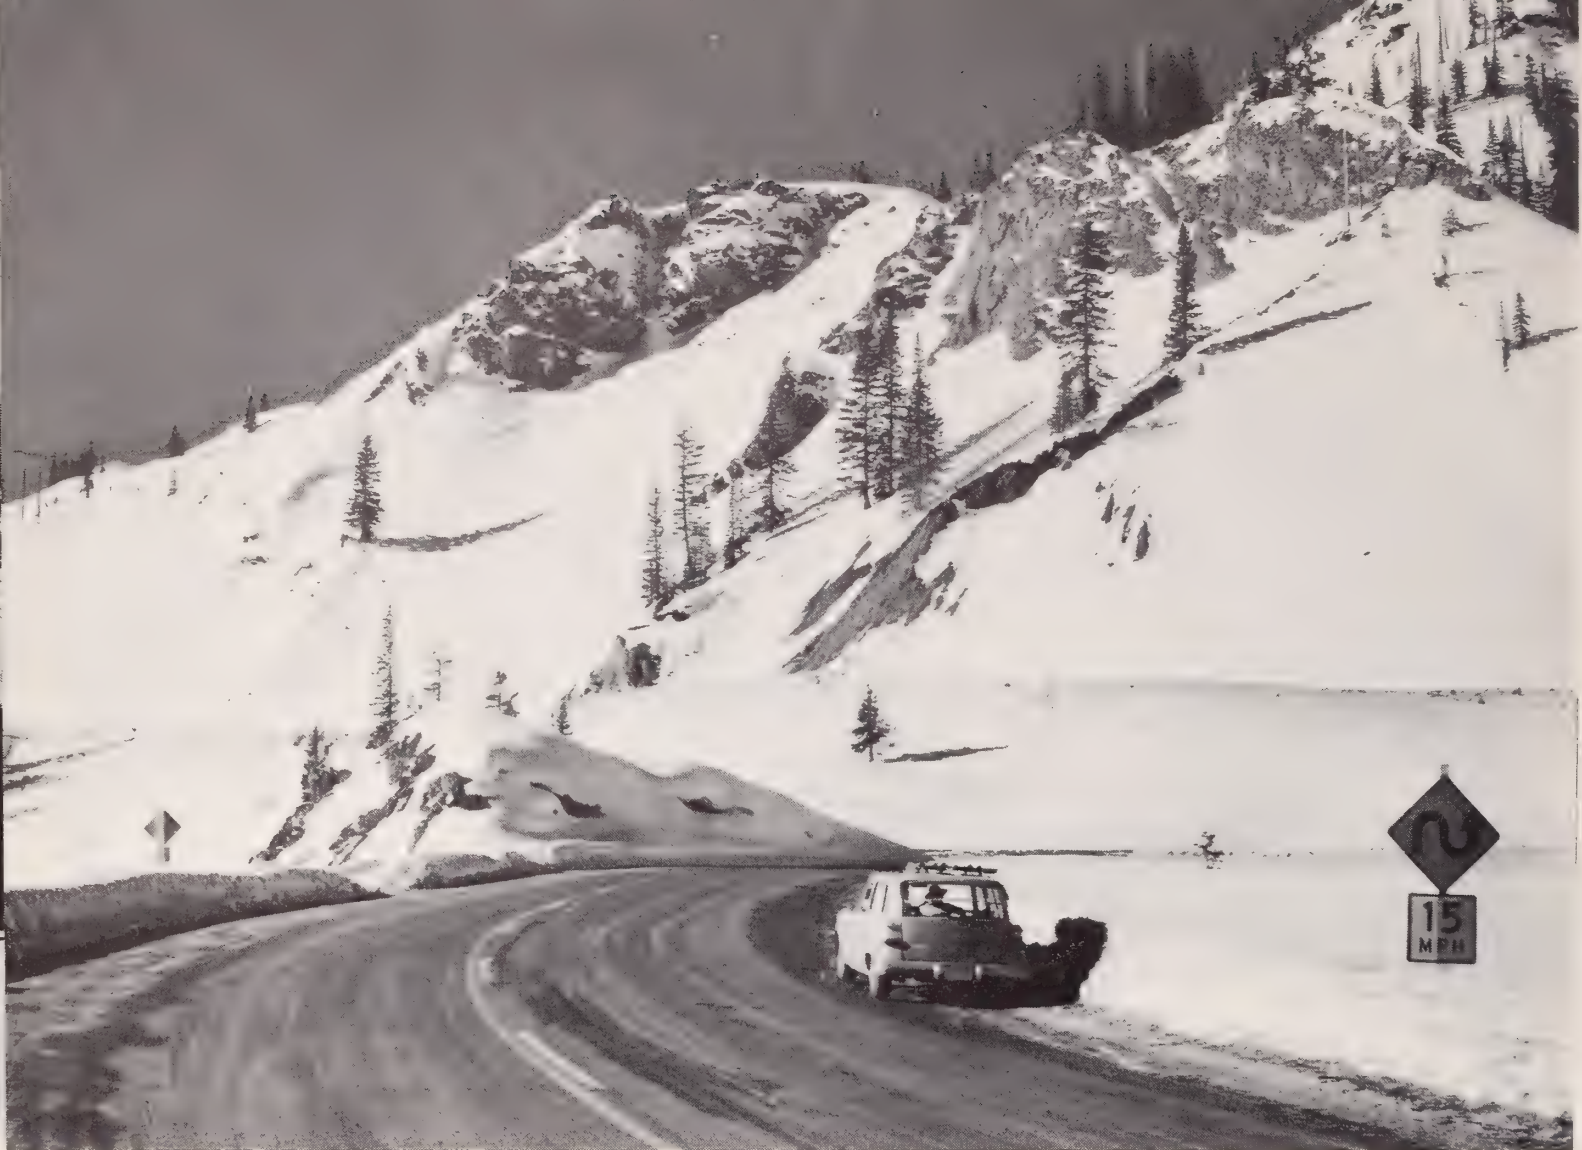
BLUE POINT (R-18)

Highway No. 550 --
Red Mountain Pass
Photo: January 3, 1962

Snow nets are recommended. This is a good example of where supporting structures should be used.

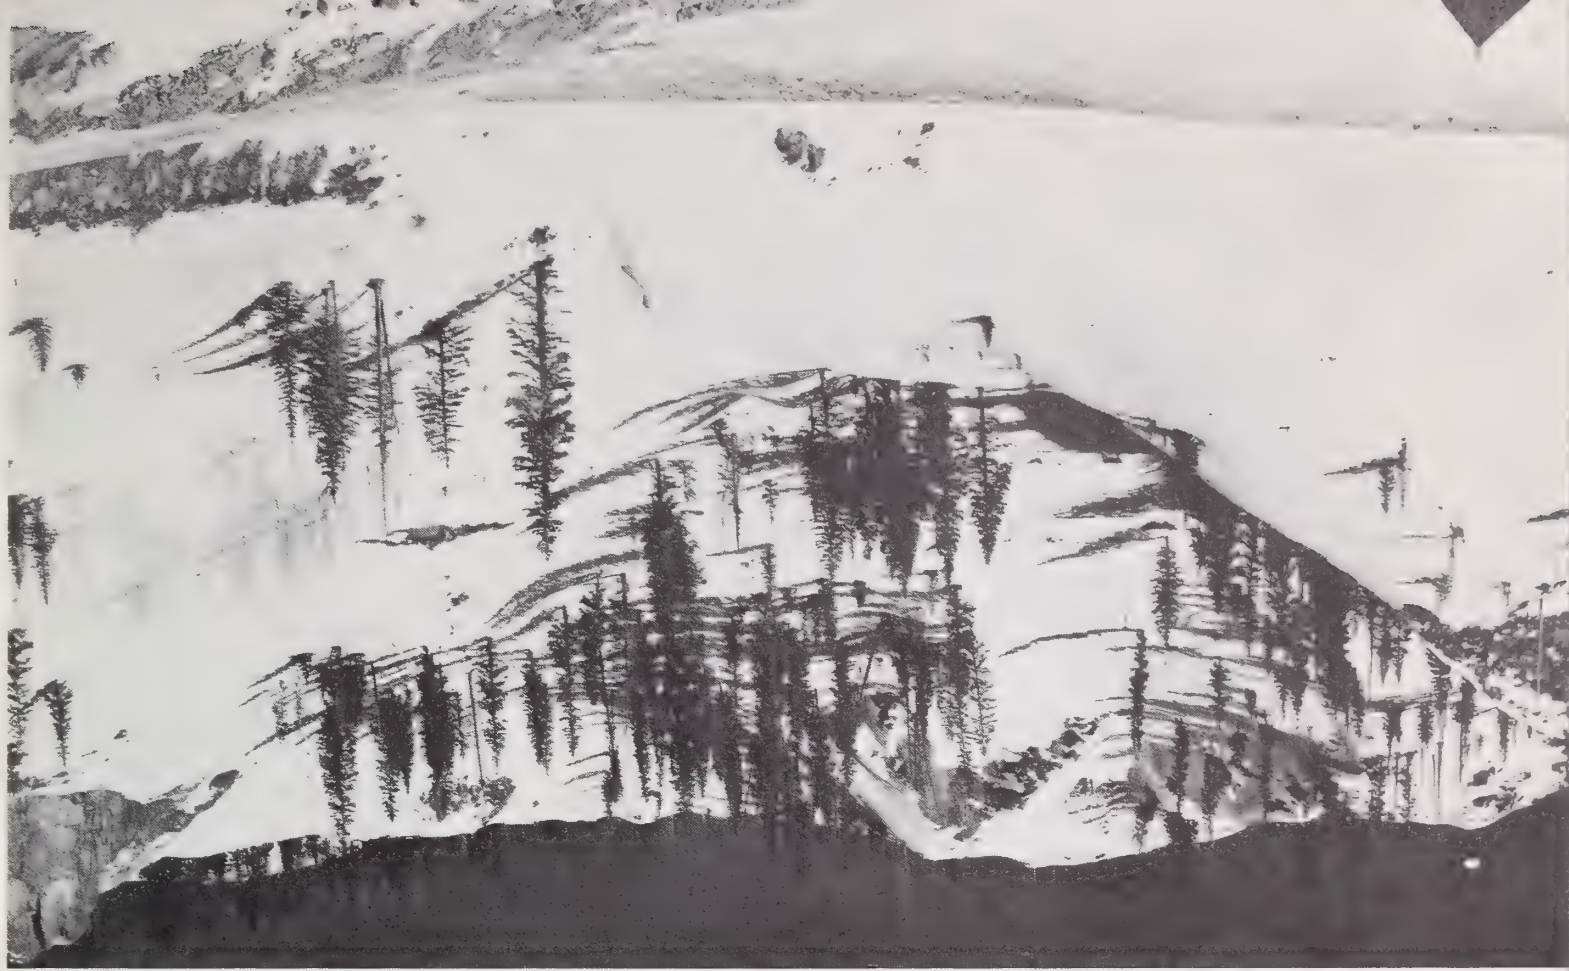
GOVERNOR GULCH (R-21)

Highway No. 550 --
Red Mountain Pass
Photo: July 2, 1962

The erosion funnel of Governor Gulch gives more trouble with floods carrying boulders and mud to the highway than with avalanches, which occur very seldom. Structural control of the rugged catchment basin would be very difficult and expensive. The runout zone is long enough to plan diversion or retarding structures if necessary.

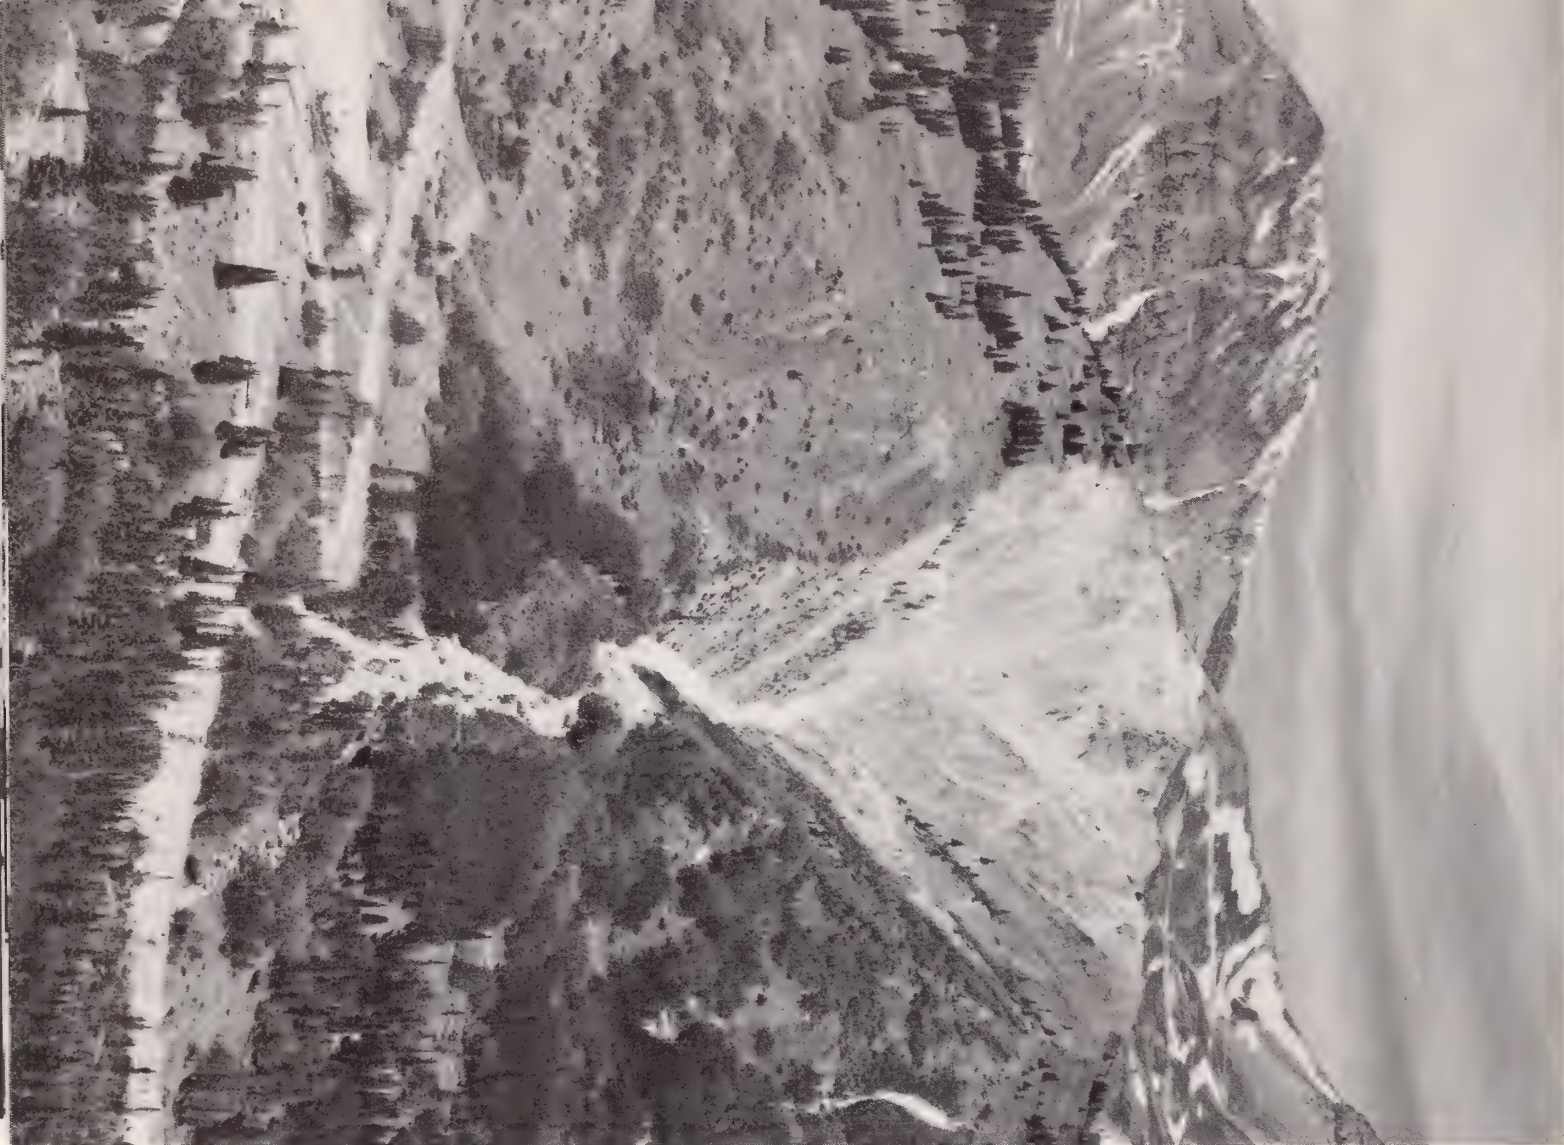
GALENA LION GULCH (R-22)

Highway No. 550 --
Red Mountain Pass
Photo: July 2, 1962

Since the runout zone is very gentle and long, avalanches seldom reach the highway. A cut in the aspen stand shows that in exceptional situations it does happen, however. If control is considered necessary, the terrain features are favorable for diversion structures.

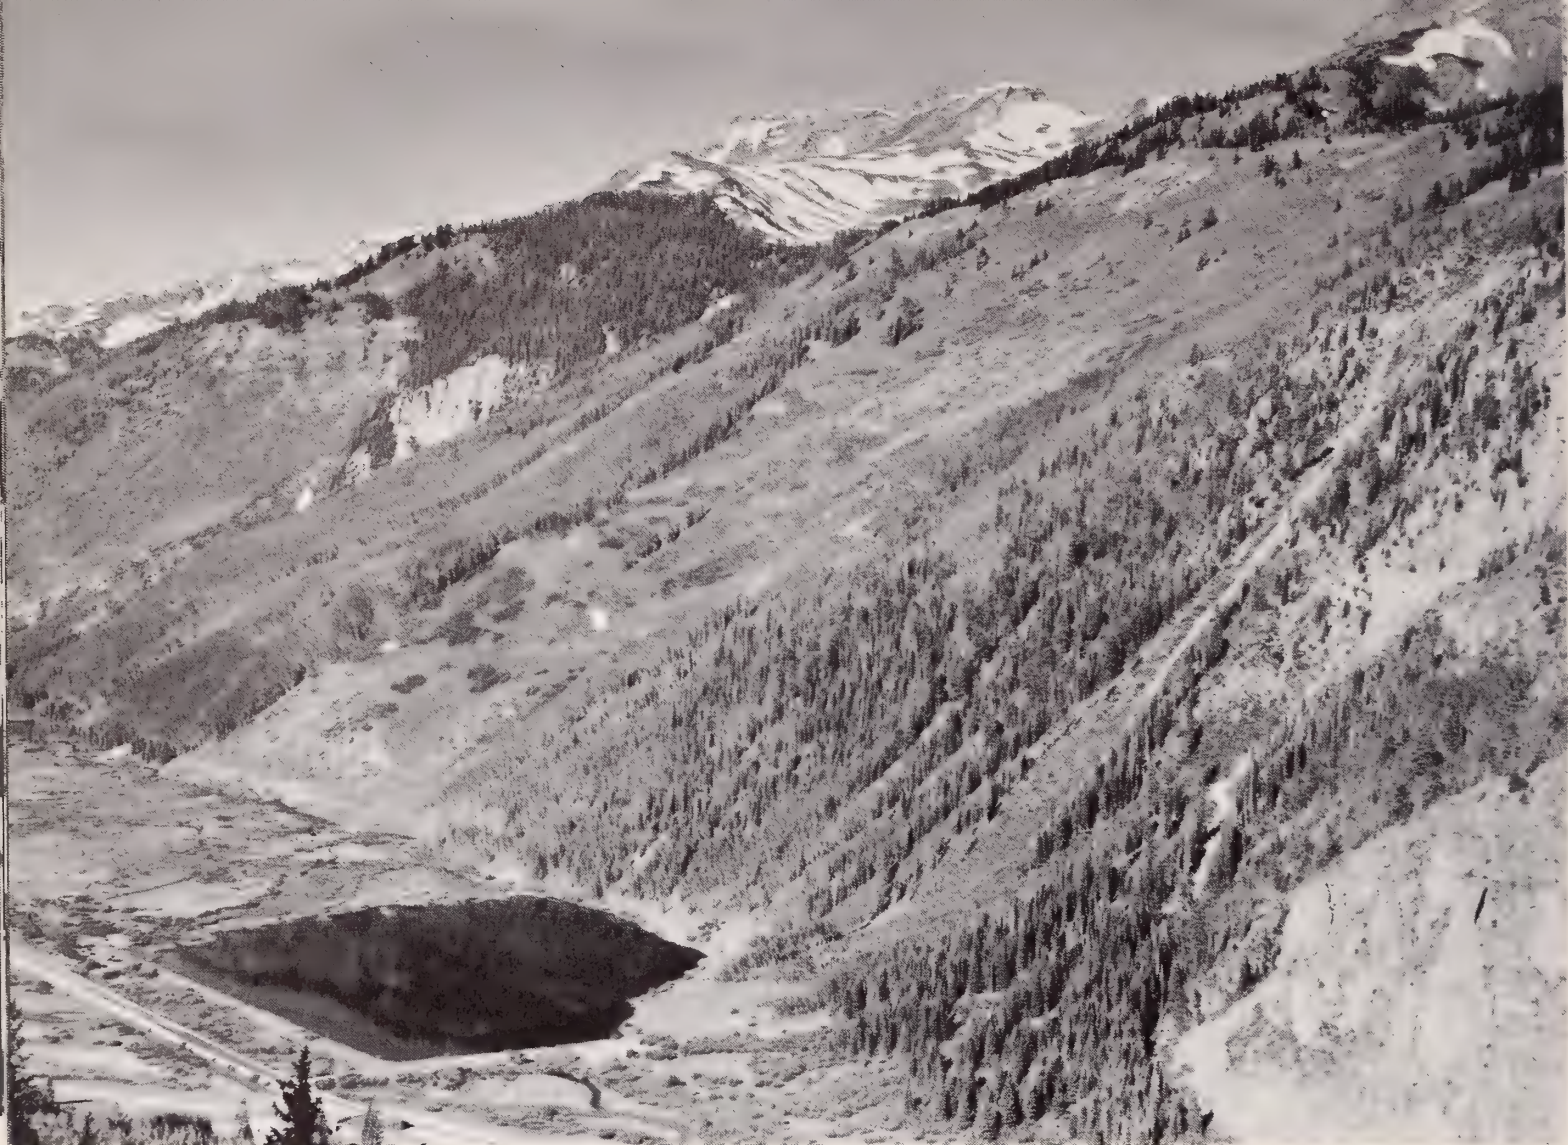
IRONTON PARK (R-23)

Highway No. 550 --
Red Mountain Pass
Photo: July 3, 1962

The only possible control is an avalanche shed, which would serve at the same time as protection against the EAST GUADALUPE avalanche.

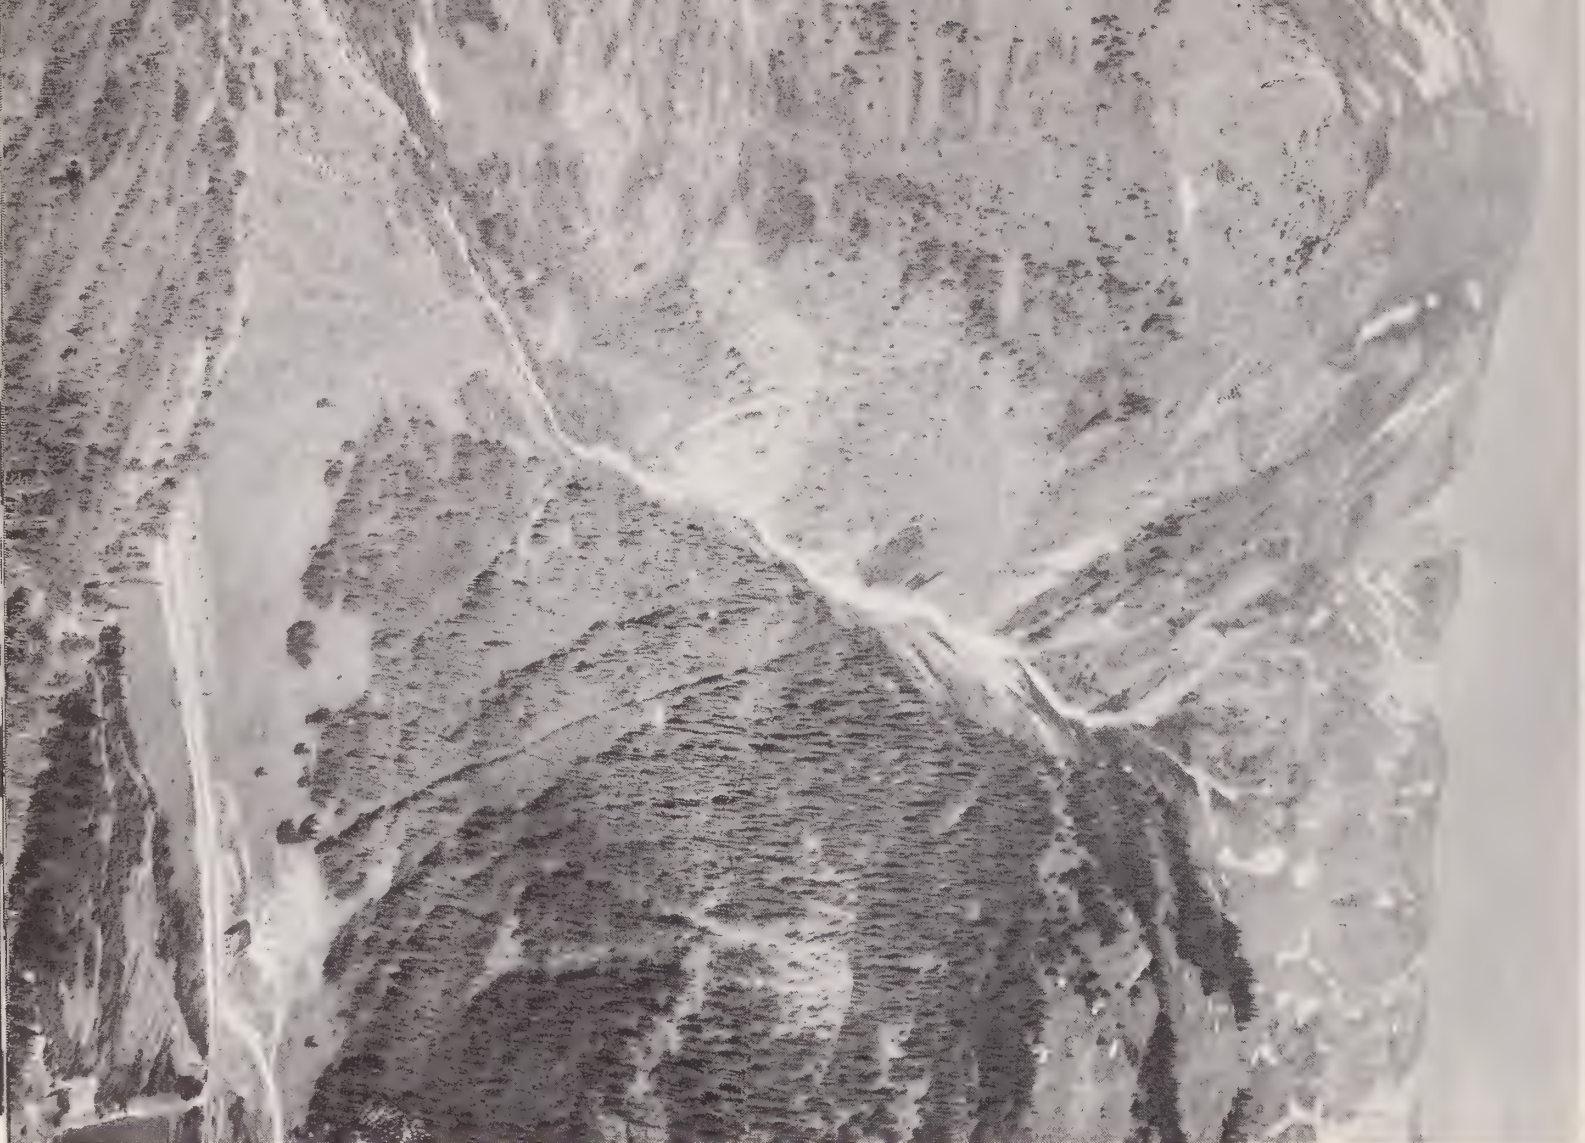
EAST GUADALUPE (R-25)

Highway No. 550 --
Red Mountain Pass
Photo: July 2, 1962

Control of the starting zone is possible. However, considering neighboring avalanches (EAST and WEST RIVERSIDE) the simplest solution would be a tunnel.

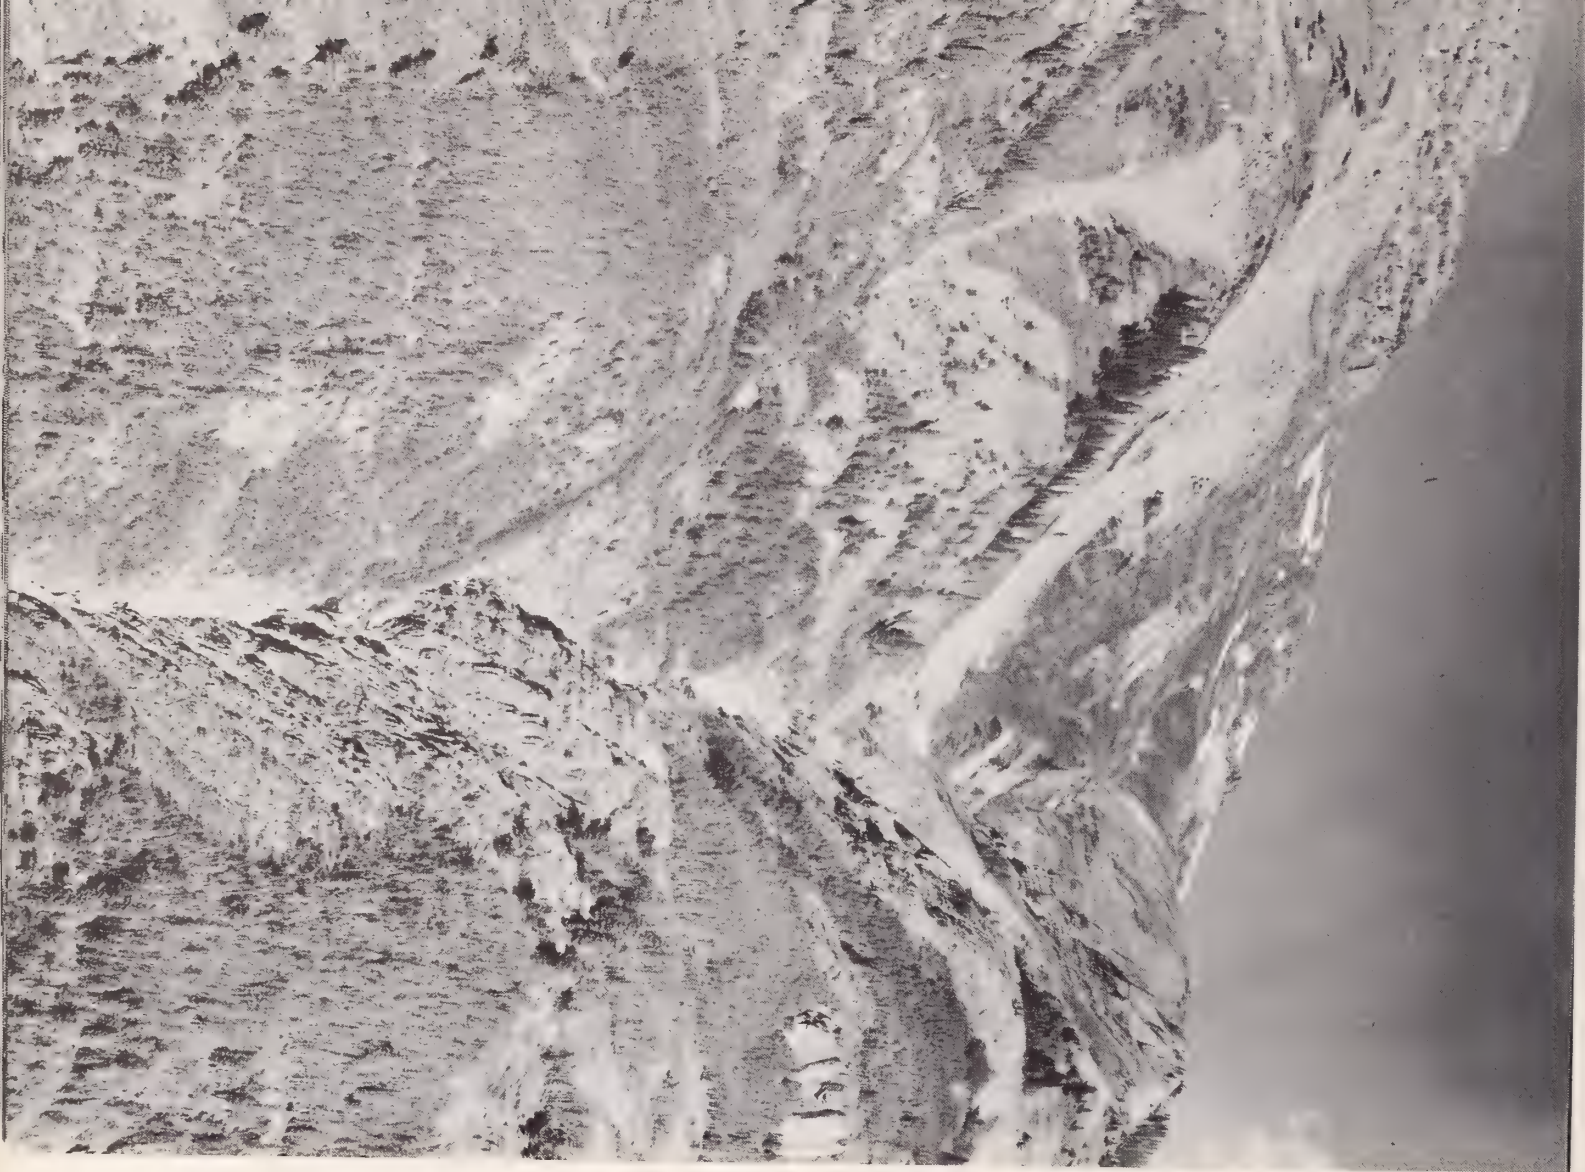
WEST RIVERSIDE (R-27)

Highway No. 550 --
Red Mountain Pass
Photo: July 3, 1962

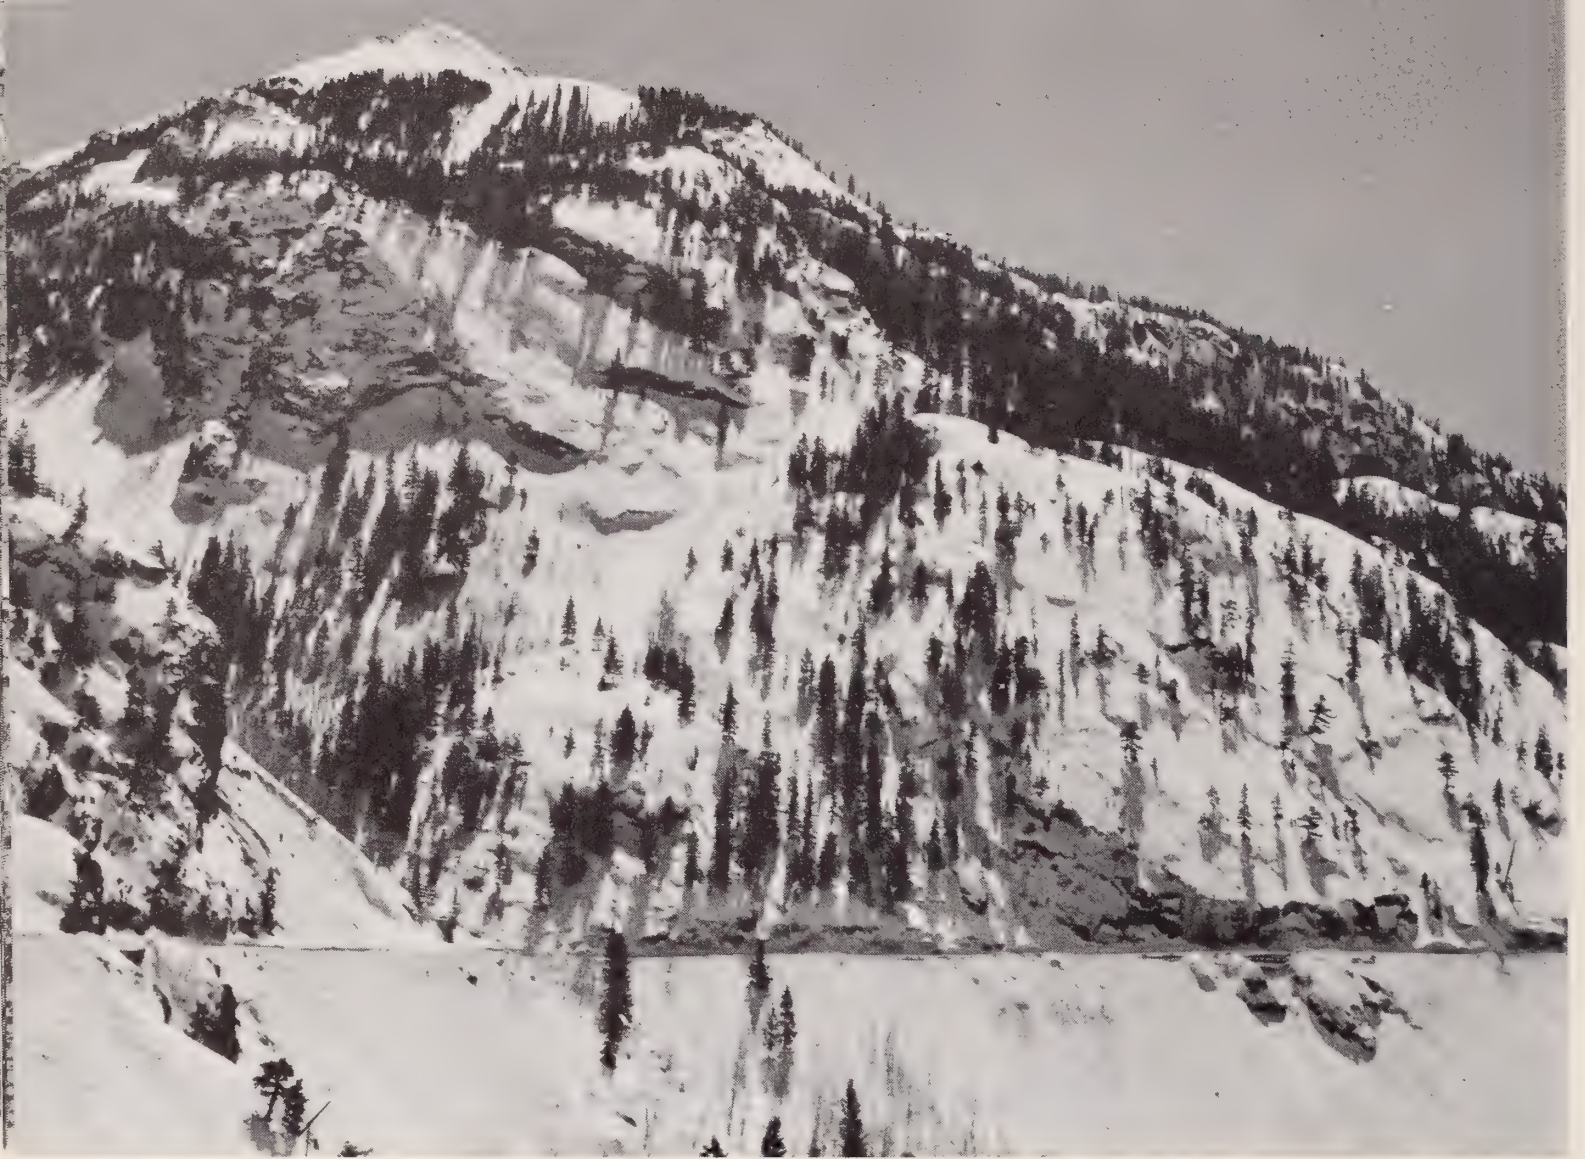
MOTHER CLINE (R-30)

Highway No. 550 --
Red Mountain Pass
Photo: March 25, 1962
